QUINQUENNIAL INSPECTION REPORTS

FOR Our Lady and St John Church and Presbytery,
Goring-on-Thames
Christ the King Church, Woodcote

DATE 2 January 2018

QUINQUENNIAL INSPECTION REPORT

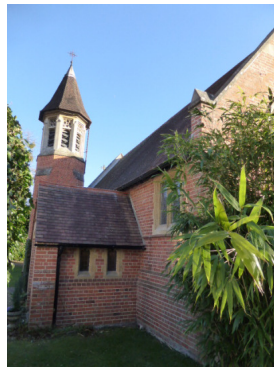
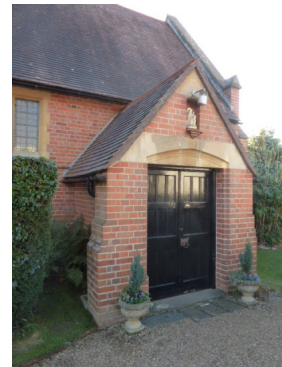
P12 & 13: N side and Porch

- 2.12 There are no particular issues to mention on the N side, or about the handsome N Porch.

- 2.13 The junction between the 1989 and 1938 construction is discernable (as it is on the S side) but the bricks seem identical.

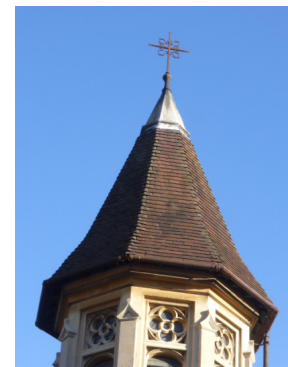
P30: Spire from W

3.20 The low octagonal spire is also covered in plain clay tiles, with angled hip tiles, apparently in reasonable condition.

3.21 It is surmounted by a large lead capping, also apparently in reasonable condition

3.22 Mounted on top is an iron cross, rusty but intact

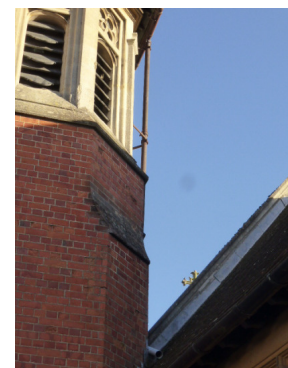
P31: Spire, W side

3.23 The guttering is the original cast iron, rusting, with holes in evidence and one corner missing its junction piece.

3.24 Although the incident rainfall is not large – there is no sign of staining below – this needs to be attended to. The eaves timbers could also then be redecorated.

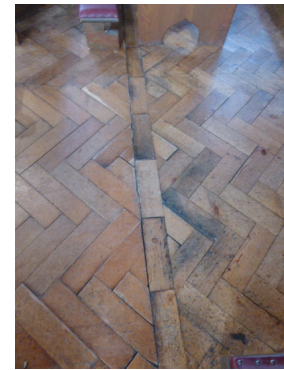
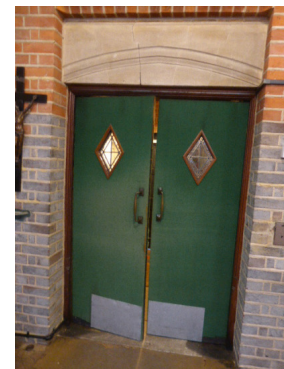
P42 & 43: Nave floor

5.18 The junction between the two types is not very level, and has become a bit untidy, with blocks loose on both sides.

5.19 This may become a trip hazard, and should in any case be improved/

5.21 The blocks underneath seem in the same condition as elsewhere, so I suggest it is removed.

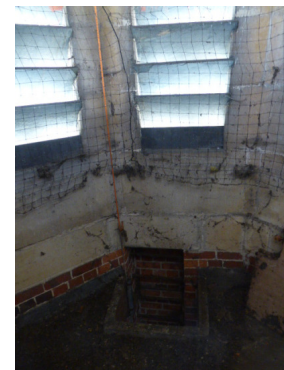
P50: Belfry floor

- 5.34 This contains a single, fixed bell. The headstock beam fixing brackets are very corroded and should be treated and coated.
- 5.35 The timber spire structure appears sound
- 5.36 The walls are of brick and limestone. The belfry openings are protected from large birds with netting.
- 5.37 The floor is lined with lead. I am unsure whether the staining below is historic or active.
- 5.38 There is a large amount of debris to be cleared out.
- 5.39 I assume this is a mixture of small bird droppings and what they bring in or is blown in.

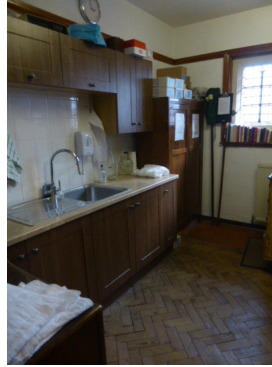
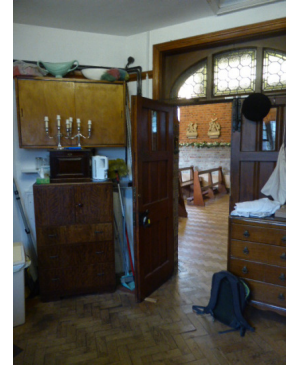
P52 & 53 : Sacristy

- 5.40 Ceilings: painted plaster with a timber ceiling hatch.
- 5.41 Walls: plastered and painted, stained timber picture rail, some splashback tiling; all sound
- 5.42 Floor: Older pine blocks, many loose.

Est cost £
11.10	Interiors	
	Repair and re-finish block flooring (5.7, 5.16, 5.17, 5.19, 5.42)	1,500
	Renew felt covering to D3 (5.23)	250
	Redecorate Chapel ceiling (5.29)	750
	Rust protect bell fixings (5.34)	50
11.11	Disabled access	
	Develop plans for DWC (9.4)	-
	TOTAL	£10,050

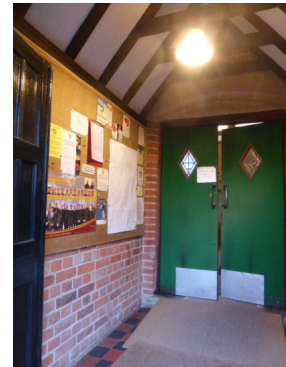
P54: Porch interior

- 5.45 Ceiling: painted plaster between stained rafters / collars, in fair condition.
- 5.46 Walls: brickwork as elsewhere, sound.
- 5.47 Floor: Quarry tiles, sound. There is a temporary plywood ramp for wheelchair access (see below). The mat is unfixed and seems to present a trip hazard as you come down the ramp.

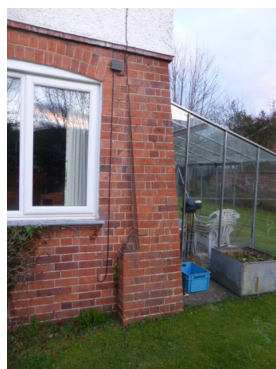
P4: SW corner

2.2 This may once have been quite a stylish house – note the unusual buttressed corner on the SW, the brick arches, and the corbelled projections on the W elevation..

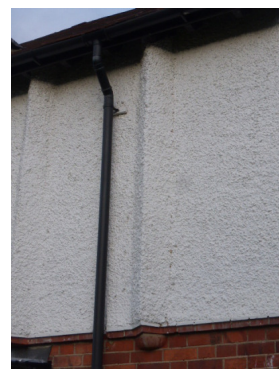
P5: S elevation

2.3 The windows have now mostly been replaced in the inevitable PVC, rather crudely fitted.

2.4 The lead cills were left in place, but are generally cracked and failing.

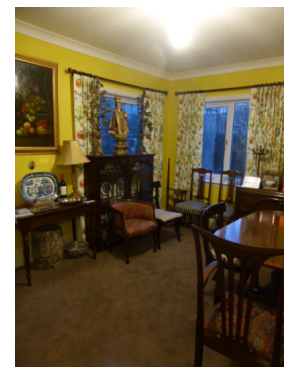
P26: Dining Room

6.26 Fireplace has been panelled over with no air vent, but there seem to be sufficient gaps around the panelling.

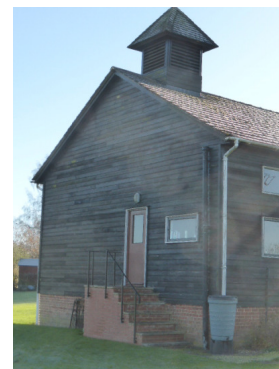
P6: View from NW

2.8 The photo P6 shows the rather odd external steps in brickwork and concrete flag treads: they are too steep, with irregular risers

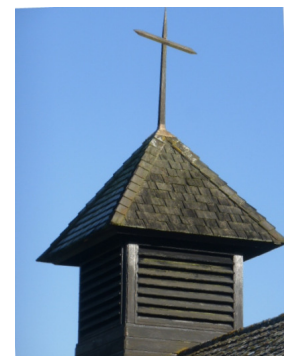
P16: Bellcote support

- 4.2 It has a small lead flashing on its apex, and a metal cross, the cross-arm of which is loose.

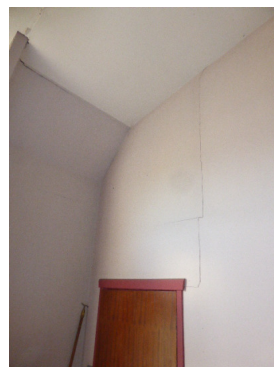
P28: Vestry S wall

7.26 There is some movement cracking in both.

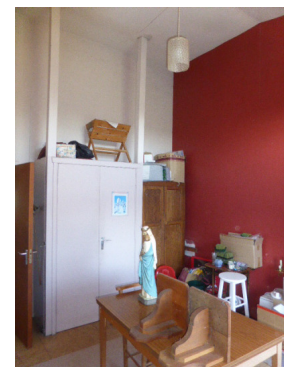
P29: Vestry looking NW

7.27 Around the tops of the posts (which support the bellcote) can be seen water staining. This is likely to be condensation due to the lack of insulation. B, C

13.6	Roofs, roof structures and rainwater disposal Provide loft insulation and access walkway (3.5, 7.77.27)	1,500
13.7	Interiors Provide ventilation to WC (7.33) Provide hot water to basin (7.34)	350 200
13.8	Heating system Add timer control to radiant heaters (8.2)	100
13.9	Other electrical systems Replace lamps with LE type (9.1, 9.2)	200
13.10	Externals Repair bellmouth tarmac (12.4)	750
TOTAL		£3,100

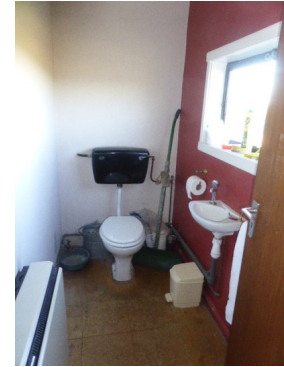
P30: WC

7.33 There is no form of ventilation – the window vent is painted up.

7.34 There is no hot water provided.
