QUINQUENNIAL INSPECTION REPORTS

FOR Our Lady and St John Church and Presbytery,
Goring-on-Thames
Christ the King Church, Woodcote

DATE 2 January 2018

QUINQUENNIAL INSPECTION REPORT

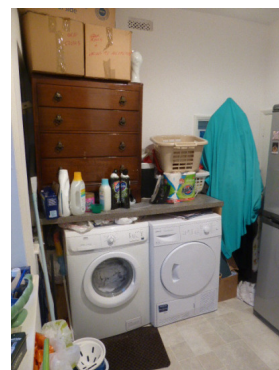
P22: Utility Room

6.4 Door from Lobby has been removed.

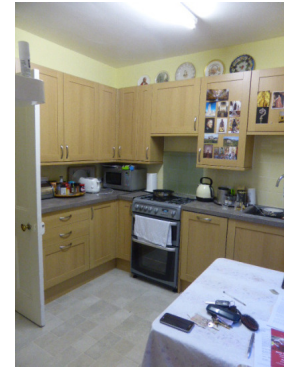
P24: Kitchen

6.10 Floor: new sheet vinyl on suspended timber, apparently sound.

6.11 Fittings: all new

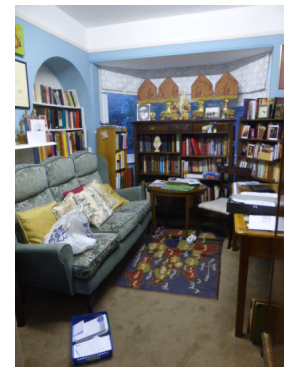
P25: Office

6.21 Floor: carpeted.

6.22 Door: panelled, with nightlatch added, sound.

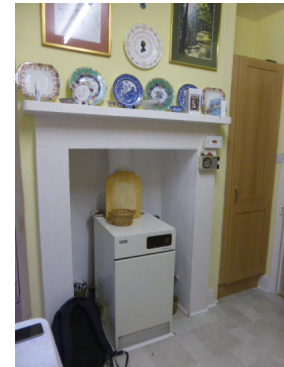
P30: Boiler in Kitchen

- 7.5 I have no information on dates when the heating systems were last inspected. An examination and test should be made by a qualified engineer annually.

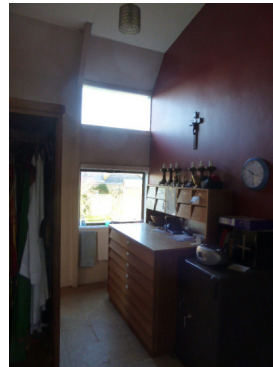
P31 & 32: Sacristy

7.36 Minor movement cracking in wall with back door lobby.

7.37 Fittings: oak veneered vestment chest and wardrobe, sound; safe
